Manhole Inspection Summary

Manhole # S09QQ1036MH

Insp Date: **12/8/08 9:54 AM**

Location Address: **5100 PALMER AVE**

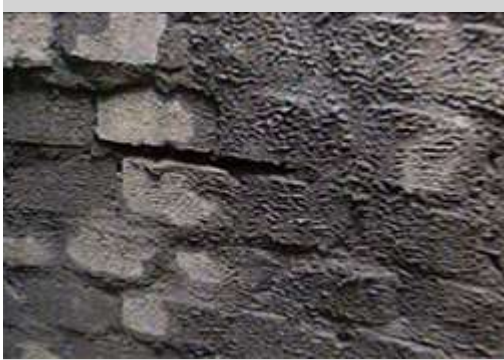
Defect 5

Infiltration: ☐ None ☐ Joint ☐ Cracks ☐ Mortar ☐ Roots ☒ **Wall**

INFILTRATION OF CORBEL WALL

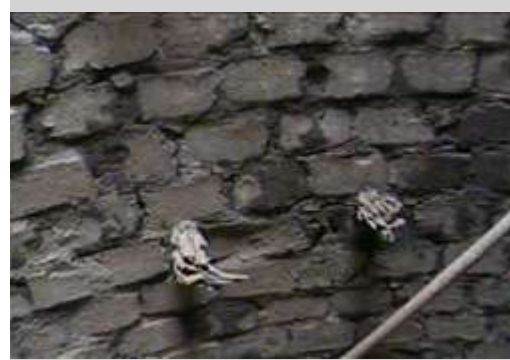
Defect 3

INFILTRATION OF CORBEL WALL

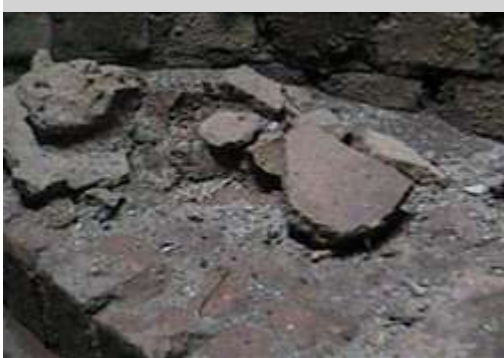
Defect 1

Steps Count: **3** Missing: **3** ☒ **Corroded**

STEP CORRODED AND MISSING

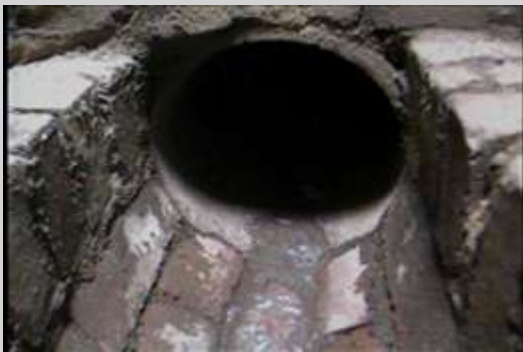
12 O'Clock Outflow

8 in. Circular Gravity Sewer
Pipe Out @ 12 O'Clock

Pipe Height: **3.6** (in.) Rod and Bar
Pipe Material: **Clay** ☐ Pipe Lined
Invert Depth: **6.81** (ft.) Flow Characteristics: **None**
Deposits: ☒ None ☐ Mud ☐ Sludge ☐ Debris ☐ Grease
Silt Depth: (in.) Deposits Extent:
Infiltration: **None** Pipe Seal Cond: **Sound**

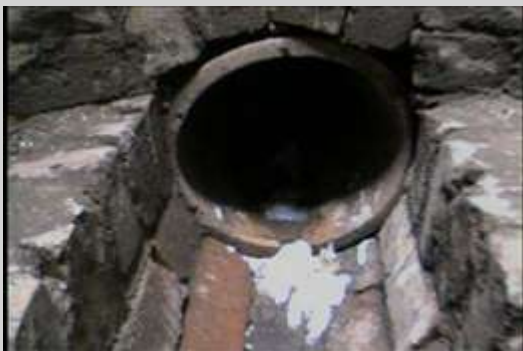
6 O'Clock Inflow

8 in. Circular Gravity Sewer
Pipe In @ 6 O'Clock

Pipe Height: **4.8** (in.) Rod and Bar
Pipe Material: **Clay** ☐ Pipe Lined
Invert Depth: **6.63** (ft.) Flow Characteristics: **None**
Deposits: ☒ None ☐ Mud ☐ Sludge ☐ Debris ☐ Grease
Silt Depth: (in.) Deposits Extent: **Light**
Infiltration: **None** Pipe Seal Cond: **Sound**
